Report

Serious incident on **15 April 2010**
south-east of Brive-la-Roche (19)
to the **Hawker Beechcraft Corporation Beech B200GT**
registered **F-HSFA**
operated by **SEFA**

BEA

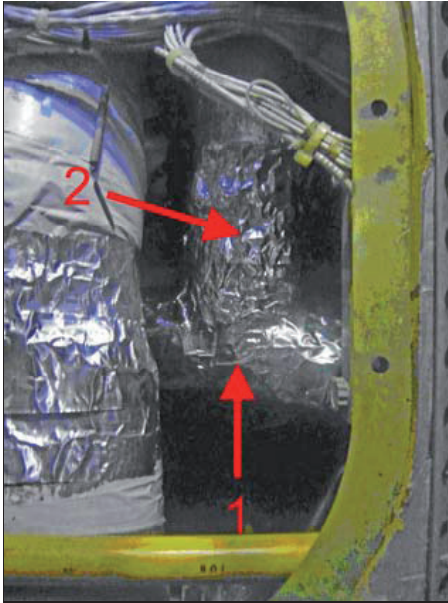
Figure 3: The “flapper valves” sleeve (1) and the sheath (2) wrapped in their heat insulation

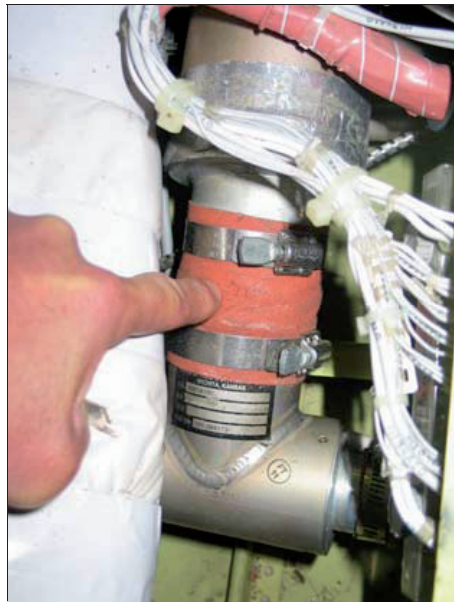
Figure 4: The same equipment after removal of heat insulation

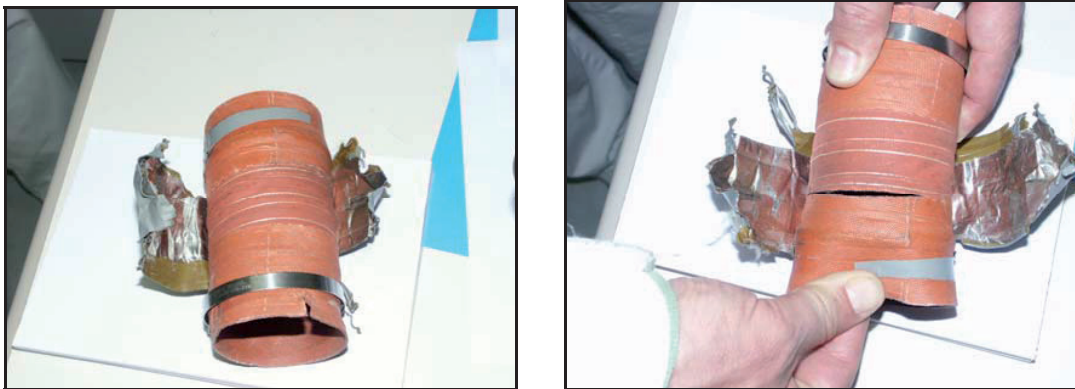
The maintenance operations carried out after the incident showed that the flexible sheath (ref. 515 in figure 2) was split and surrounded by a grey adhesive overlaid on a sheet of aluminium. They both bore traces of over-heating and were ripped:

Figures 6 and 7: Flexible sheath split with its adhesive

The investigation showed that the acrid irritating smoke came from the deterioration of the adhesives in contact with a damaged warm air duct. The weakening of the latter from damage and the crew's manual request for heat, difficult to control and thus more sudden than in automatic mode, exposed the adhesives to a greater heat than they could tolerate. The air flow and temperature were not enough to trigger the overheating and leak detection systems.

The production of smoke came from the melting of adhesives attached to a warm air duct damaged by a maintenance action undertaken with an inappropriate sharp instrument.

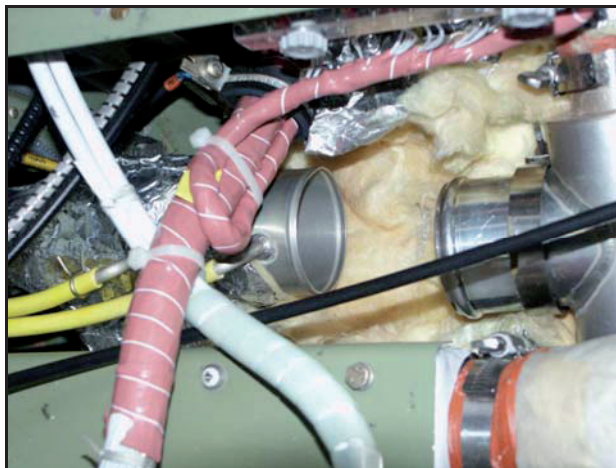
In the photograph below, taken after the removal of the sheath, the metallic sleeve of the flapper valves and the entry of the venturi (in the centre) can be seen. The sheath area does not show any traces of over-heating.

Figure 8: Sheath area.
